Report on the
Twelfth Season of the Joint Swiss-Egyptian Mission
in Syene / Old Aswan (2011/2012)

Cornelius von Pilgrim, Wolfgang Müller and Helmut Schwaiger

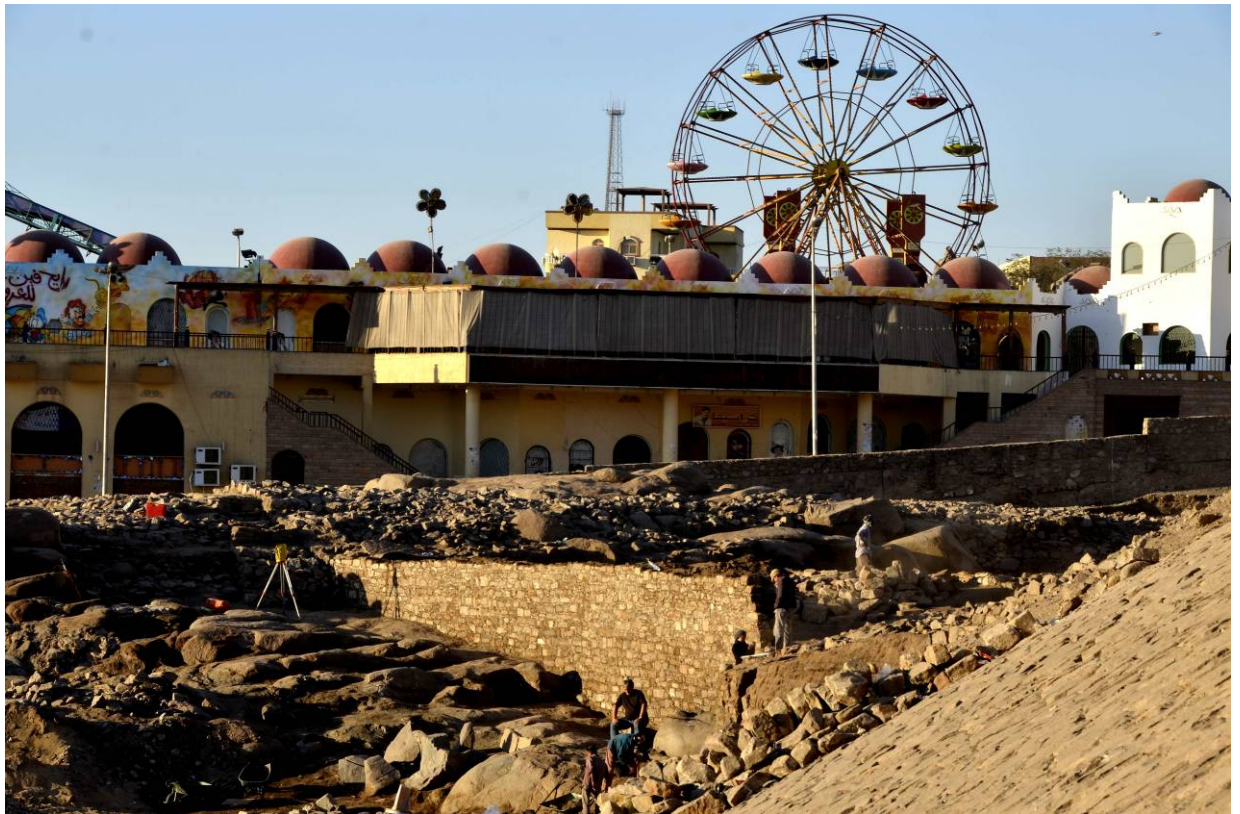
Fig. 2: Area 2: Conservation of the town-wall (photo: SIK/AK).

With a future opening to visitors of the site of Area 2 as part of a central archaeological zone in mind, a restoration of the town wall of the Late Period was started². Whereas parts of the wall are well preserved and stand to a height of four meters, a wide lane had been cut into the eastern section of the wall when the area had been misused in the past by the neighbouring Cleaning Company. It was decided to execute the reconstruction of the wall in a discreet and unobtrusive manner. The missing section of the wall, which originally consisted of undressed granite rubble, was rebuilt with walls of small used sandstone blocks and mud mortar in order to allow the viewer to distinguish between ancient and added stonework (Fig. 2).

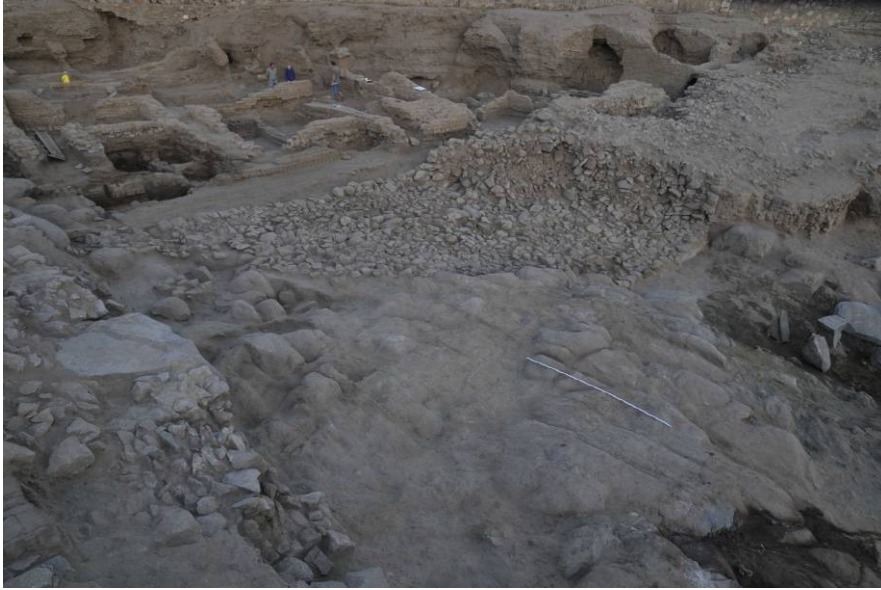
Fig. 5: Area 2: View of the Breach from the south-east (photo: SIK).

The southern part of the eastern sector of the wall was almost completely destroyed for a length of approximately 18m (Fig. 5). The breach was most probably caused by the use of heavy equipment such as front-loaders at an unknown date as traces of excavator shovels were found all over the area. The wall was already damaged when HORST JARITZ drew the first plan of the site in 1991.¹¹ The breach was then still covered with windblown sand and debris. After cleaning, it became obvious that the course of the western face of the wall was completely preserved for the whole length of the breach. A small part of the eastern face was completely destroyed but even there slight traces were still visible on the exposed granite surface. The course of the wall could thus be reconstructed for the complete breach-area. A small trench dug at the western face of the wall and investigations in the areas where the wall was already destroyed, showed that the outer faces of the wall rested on the granite bedrock. As the surface of the bedrock sloped up from west to east, the wall was founded deeper and thus was better preserved in the west than in the east. While the westernmost 2m of the wall were partly dug into quarry debris that had accumulated during the Pharaonic period,¹² the centre of the wall rested on the same material that consisted mostly of densely packed granite chips and sand.¹³

The partial destruction of the wall in the area of the breach provided a unique opportunity to study the construction of the earliest phase of the wall in great detail. The outermost 1.5 – 2m of the wall were constructed of stones (predominantly rose granite but also other local granite derivatives) slightly larger than those used for the core and were laid carefully in such a way as to create a smooth face to the wall. Only at the outer limits of the wall was mud mortar used. The core of the wall was made of loosely packed granite rubble of different sizes. The outer face of the wall was coated in a thick layer of white painted mud plaster. The wall showed different degrees of banking, but was generally significantly wider at its base than at the (reconstructed) top. The width of the wall as seen on the plan has therefore always to be regarded as dependent of the preserved height of the wall at a given location. Even taking this into account, the width of the southern sector of the wall increased significantly from north to south and reached its maximum next to the bastion, at more than 9.5m at the base while it was only approximately 5.5m wide further to the north at the top of the stone part of the wall (here several layers of mud-bricks of the original superstructure were still preserved).

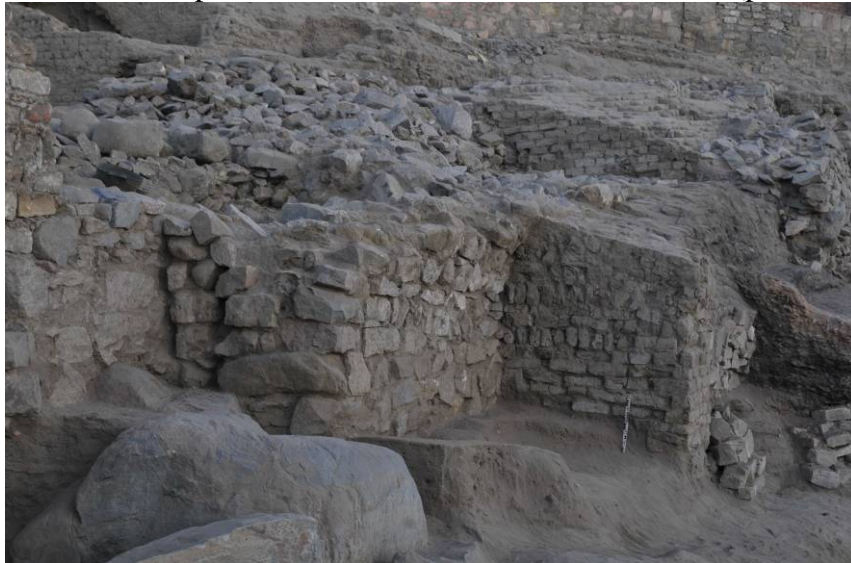
Fig. 7: Area 2: View of the Ptolemaic casing (photo: SIK).

The earliest casing of the wall was set against the eastern face in the Late Ptolemaic Period (Fig. 7). It consisted mostly of sandstone and some granite at the face and granite rubble at the core. At the time of construction of this casing the original city wall was only preserved to a height of 2.40m. The 1.30m wide casing was set against the face of the earlier wall (with the original plaster still preserved). The granite filling adjoining the casing covered the remains of the Late Period wall. The city wall in this area was therefore reconstructed to a considerable degree in the Ptolemaic Period. The fact that the original southern end of the casing was situated just to the north of the breach proves that the damage to the city wall was of a local nature. Soon after its construction the casing started to collapse, probably due to its weak foundation as it was set on layers of loose wind-blown sand. A crack was visible in the southern face of the casing and its preserved upper courses tilted slightly towards the east.

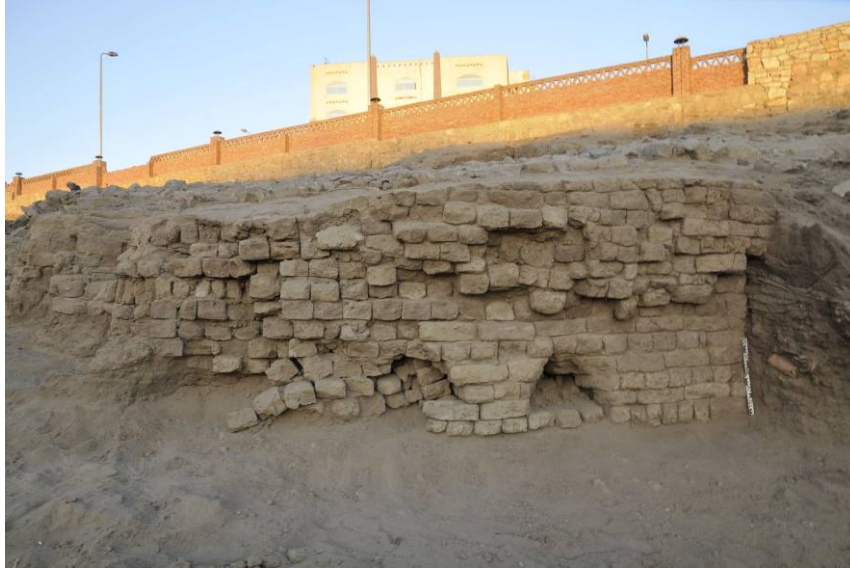
Fig. 8: Area 2: Early Roman repair work at the town-wall (photo: SIK).

The poor shape of the Ptolemaic construction soon necessitated further repair work. A mud-brick wall was set against the face of the earlier casing (Fig. 8). The wall showed two distinct phases. At first a 1.60 – 1.70m wide wall was built against the eastern and southern face of the casing. The northern end of the construction was preserved while the southern end was destroyed when the breach came into existence (the north-south extension was 6m + x). While the building process was still under way, the construction changed considerably. During the first phase the bricks were laid in an orderly way. The later wall was erected in a kind of casemate construction on top of the earlier one. The faces of the wall were proper mud-brick

walls, and the core consisted of thrown-in mud-bricks and mud-mortar. In the second phase the wall protruded significantly further towards the east and thus became a buttress that supported the town-wall at a weak point. For both phases of the wall and the patching on the surface of the town wall (Fig. 10) the same kind of bricks was used. The most remarkable features of the sandy mud-bricks were small holes, indentations of fingers pressed into their broadest-surfaces.¹⁵ This repair phase most probably dates to the Early Imperial Roman Period.

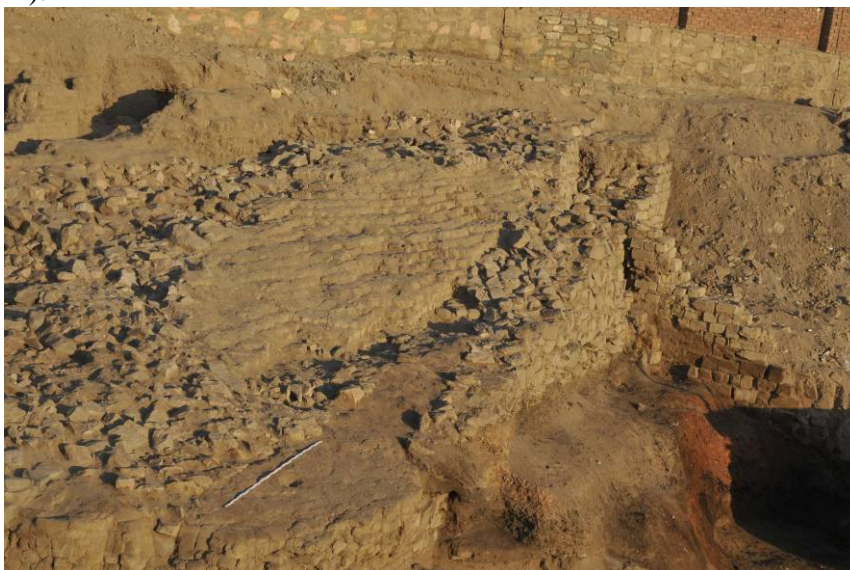
Fig. 10: Area 2: Late Roman casings at the eastern face of the town-wall (photo: SIK).

After a considerable amount of time, probably in the Late Roman Period, another casing was erected against and on top of the remains of the mud-brick wall (Fig. 10). It consisted of rose granite rubble and was constructed without the use of any mortar. The casing was preserved over a north-south extension of nearly 10m. At its northern end it bonded with another casing that consisted of reused, mostly decorated sandstone blocks closely resembling the Late Roman casing attached to the southern sector of the town wall. As was the case there, several courses of the mud-brick superstructure of the Late Roman city wall were still preserved on top of the casing. The northern end of the rose granite casing was rounded, probably because the sandstone casing originally ended in a tower, of which only traces of an east-west wall remained when a later tower was attached to the Late Roman casing in phase ES6. The casing was erected on more than 1.40m of settlement debris that was contemporary with the mud-brick casing. The 3rd-4th century AD mud-brick wall was already completely eroded at the time of construction of the later casing. A Late Roman date, just like that of the sandstone casing at the southern sector of the town wall, seems therefore to be the most feasible.

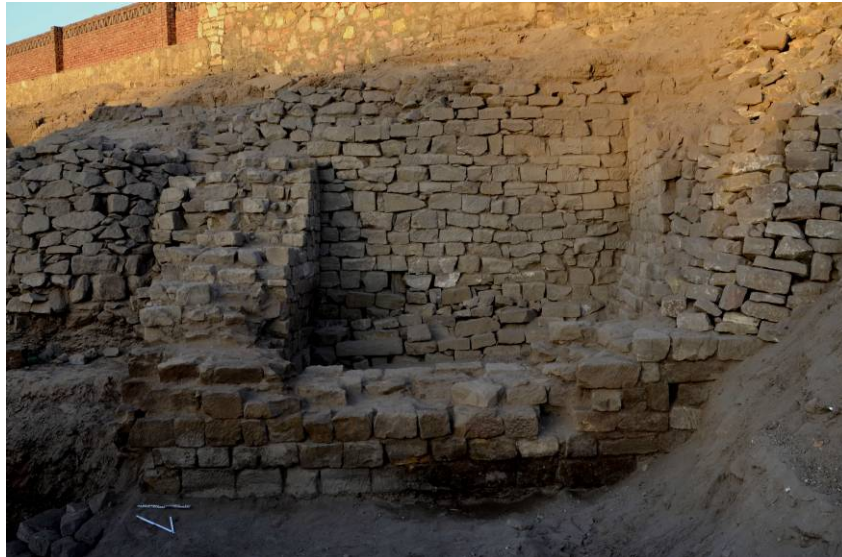
Fig. 11: Area 2: Post-Roman tower (photo: SIK/AK).

The tower abutting the Late Roman casing comprised two chambers (Fig. 11). It protruded from the face of the wall for more than 4m. Its north-south extension is given by JARITZ as 11m.¹⁶ The massive walls of the tower were 1.5m wide and made of reused blocks, some of them decorated in Egyptian style during the Imperial Roman Period.¹⁷ The wall consisted of two faces made of well laid blocks and a core of lime mortar, sandstone rubble and broken fired bricks. The dating of the tower is impossible to establish for the time being but, taking into account the facts that the masonry differs significantly from the Roman casings and that it replaced an earlier Late Roman construction, an Islamic date for the tower seems to be most probable. The tower marks the latest evidence for the existence of a town wall in Area 2.

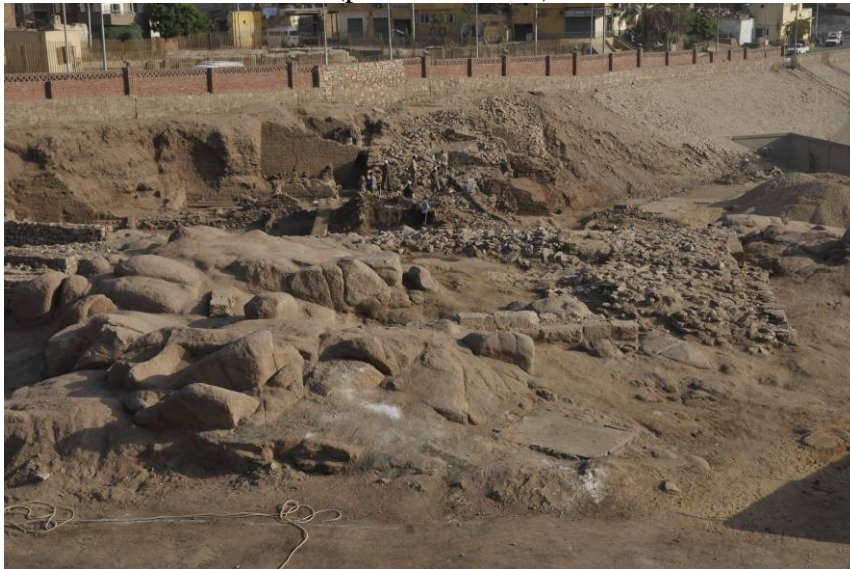
Fig. 12: Area 2: Overview of the bastion-area (photo: SIK).

Eastern and western sectors of the city wall meet at an acute angle on top of a granite massif in the southeastern part of Area 2 (Fig. 12). The area of the southeastern corner of the town of Aswan for more than a millennium was severely damaged and covered with debris and wind-blown sand at the beginning of the investigation, which produced a new picture of this crucial part of the town’s fortification. The modern northern end of the “bastion” area is the result of the destruction that happened when the wall was breached (Fig. 13).

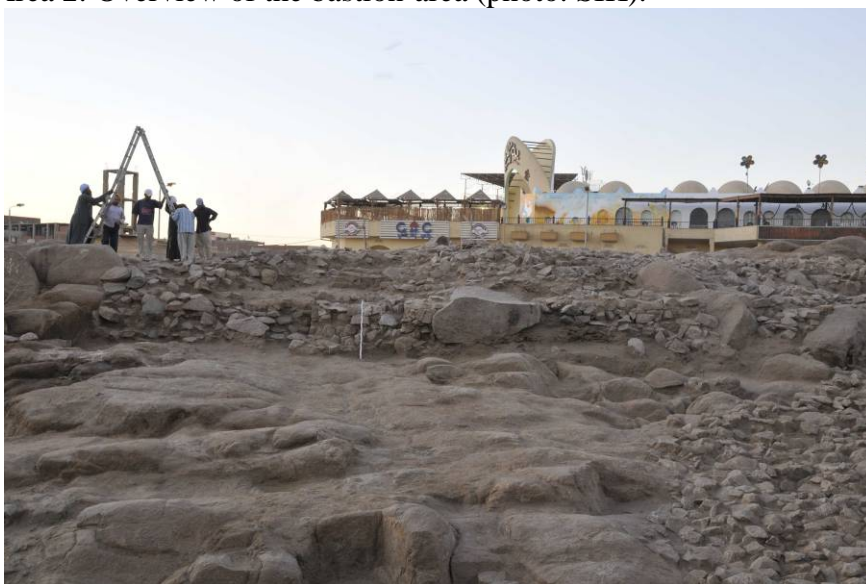
Fig. 13: Area 2: Southern section of the breach (photo: SIK).

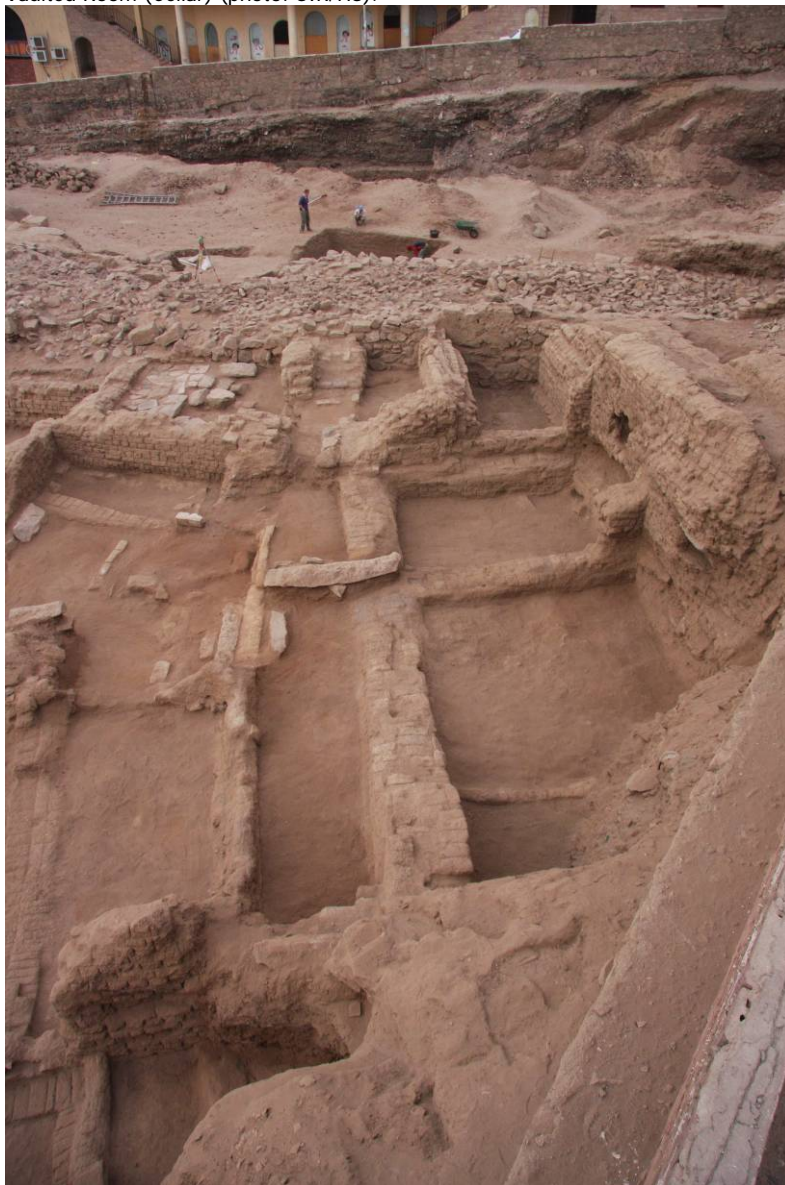
Fig. 25: Area 2: House 18 and 19 (photo: SIK/HS).

While the buildings (fig. 25) in the east continued in use, the L-shaped building (House 18/19) in the southwest was adapted. The floor plan was basically maintained but the cellar no longer had any function. Possibly it was replaced by another cellar to the west but the vault is not completely preserved. Due to the building construction, an access to the cellar can be reconstructed to the southeast. Two high steps lead to the room. Above the still extant walls, that were partially deconstructed, new mud-brick walls were erected. A part of this construction in the extension of the street was no longer integrated into the complex but was located outside it. The entrance to this house remained in the same place – as indicated by the door hinge – but placed at a higher level. In two of the rooms of the house multiple niches were discovered. Soot traces on the capstones imply that lamps were set in the niches. In a later building phase this building was divided and a door opening was simply closed up to form a long, rectangular house to the west and another house to the south. To the south a wall was cut for another entrance to allow access to the house from outside. Inside the house a pavement of rose granite chips and spolia was laid which may indicate an open room. Also, a

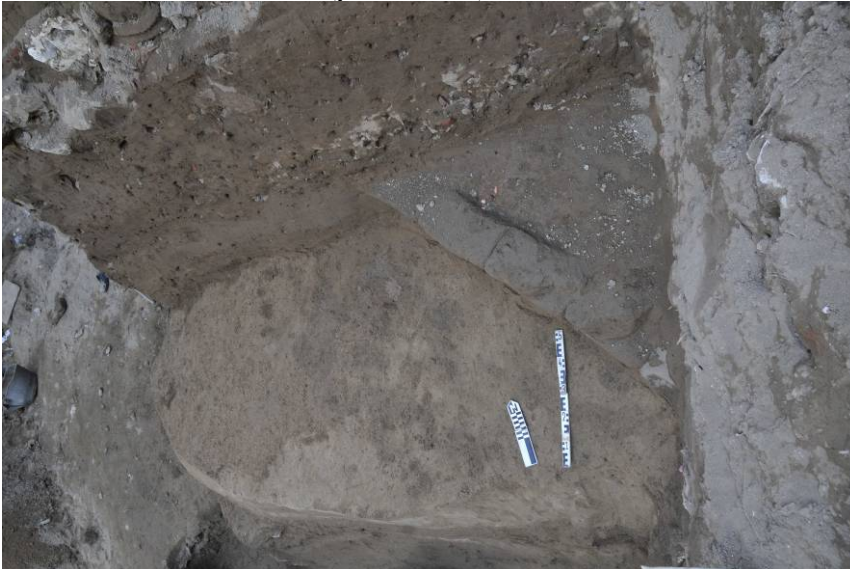
Fig. 29: Area 73: Old Kingdom structures at the northern section (photo: SIK).

A continuation of the same sequence of layers was investigated in a very limited excavation (3 x 1m) at the northern limit of the construction pit (Fig. 29). A narrow (one brick wide) mud-brick wall dating to the Old Kingdom (corresponding to stratum 5 in Area 23), roughly orientated north-south, was associated with a burnt mud surface that was covered with fragments of pottery. Separated by layers of alluvial sediments, a narrow north-south wall, situated at exactly the same location and oriented in the same direction as its predecessor, remained from a similar structure from the Late Middle Kingdom. Several mud surfaces and sandy layers were associated with this wall.

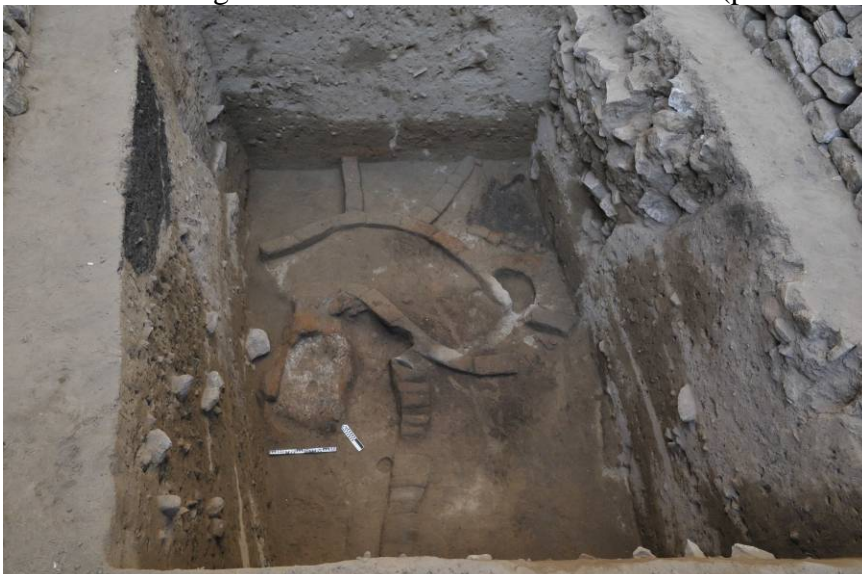
Fig. 30: Area 74: Structures of Stratum D3 (photo: SIK).

Fig. 31: Area 74: Plan of Stratum D3.

The earliest phase (Stratum D3) of Middle Kingdom ovens and workshops was significantly damaged by later activities (Figs. 30, 31). An undulating half-brick wide mud-brick wall ran in an approximate east-west direction. Two similar walls abutted the northern face of the small wall and ran into the northern section. The walls separated three small, most probably unroofed, rooms. In the easternmost room a rectangular mud-brick construction (Oven 4), filled with ash and charcoal, was located. The structure differs significantly from the other ovens, but fragments of bread-moulds found with the ash imply that it was also used for baking bread. The remains of an earlier mud-brick wall to the south of these rooms were partly reused when an oven of rectangular-ellipsoidal shape was constructed (Oven 3). The oven was oriented north-south and measured 0.8 x 1.4m. Its walls were made of mud-bricks. A part of its collapsed flattened dome was still preserved at its northern end.
